SECTION 4: OVERALL ANALYSIS AND RECOMMENDATIONS

Downtown Navasota Parking Study

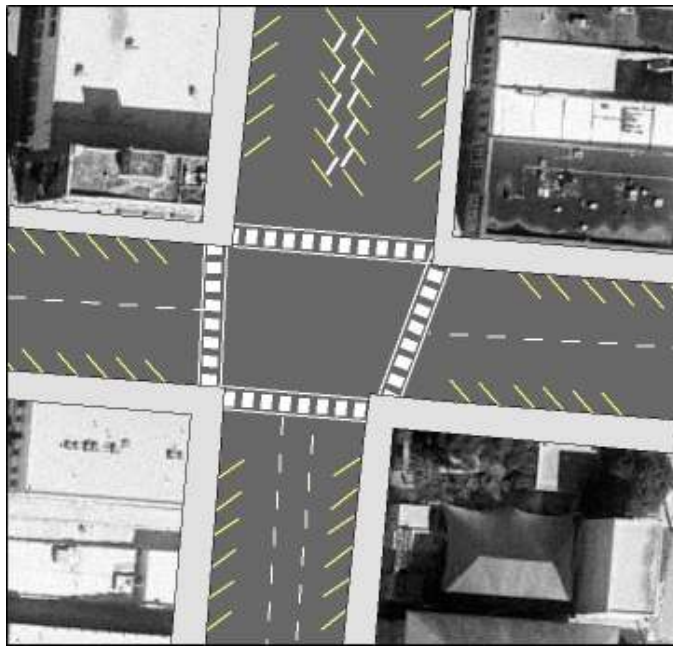
Figure 4.1: Typical sidewalk and crosswalk design

Figure 4.1 is a hypothetical streetscape design which utilizes many of the concepts that will be discussed. This Figure represents a streetscape not unlike those currently found in Downtown Navasota. Sidewalks are relatively straight, striped parking is provided with blank areas at intersections, and crosswalks are simply painted white. This design presents several problems for the pedestrian. Because parking is usually not striped all the way to the end of the street, drivers frequently use the un-striped areas as de facto right-turn lanes. Additionally, crosswalks marked with white paint frequently fade and do not represent a "solid" marker.

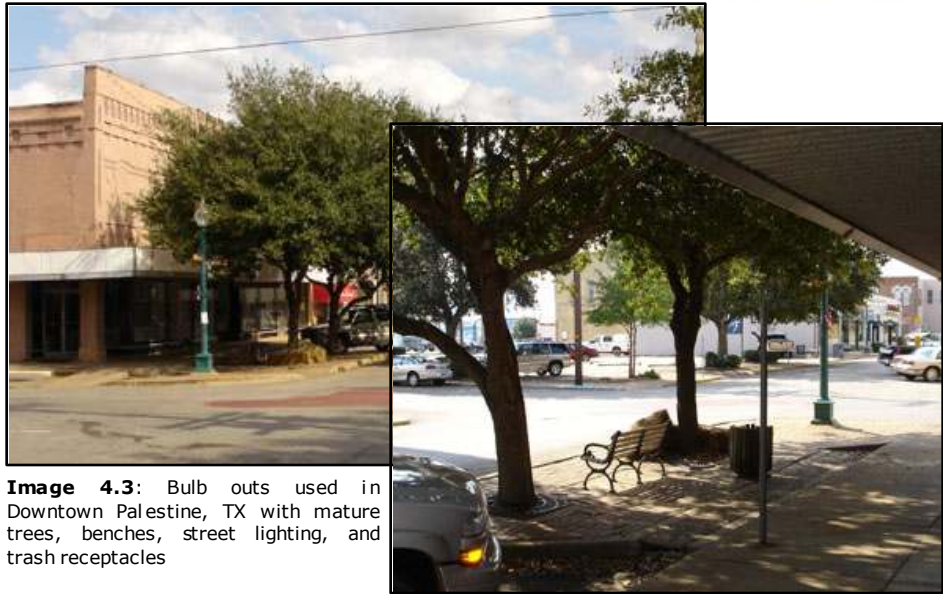
Image 4.3: Bulb outs used in Downtown Palestine, TX with mature trees, benches, street lighting, and trash receptacles

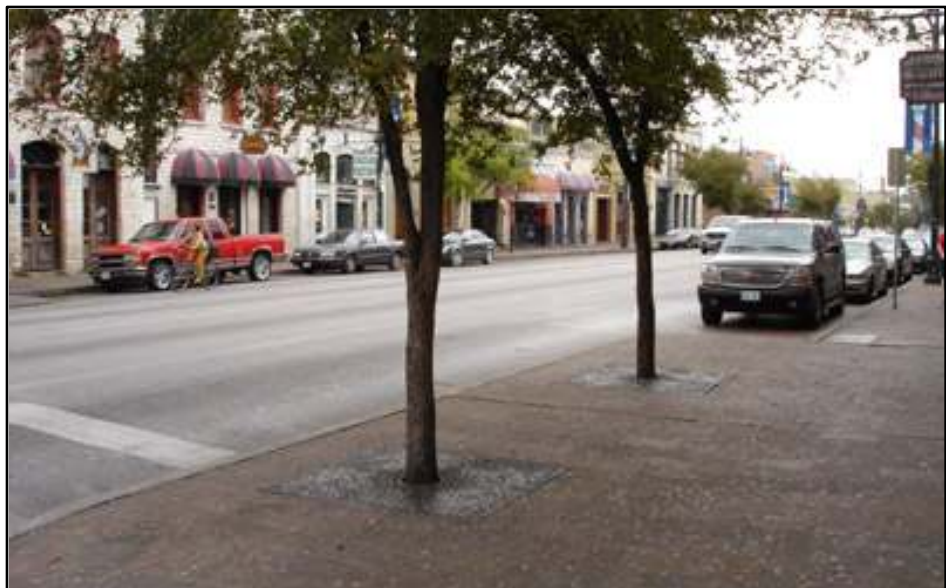
Image 4.4: Bulb out in Downtown Austin, TX with young street trees and brick paving

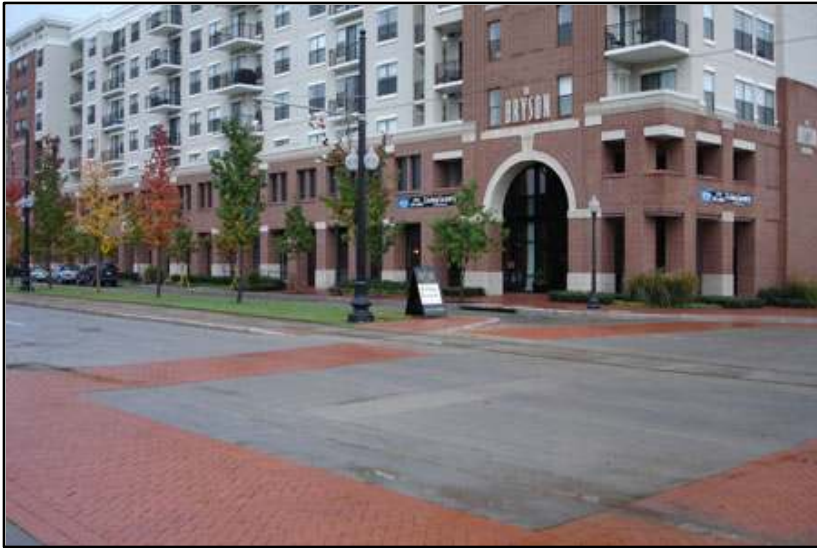
Image 4.5: Brick paved crosswalks in Dallas, TX

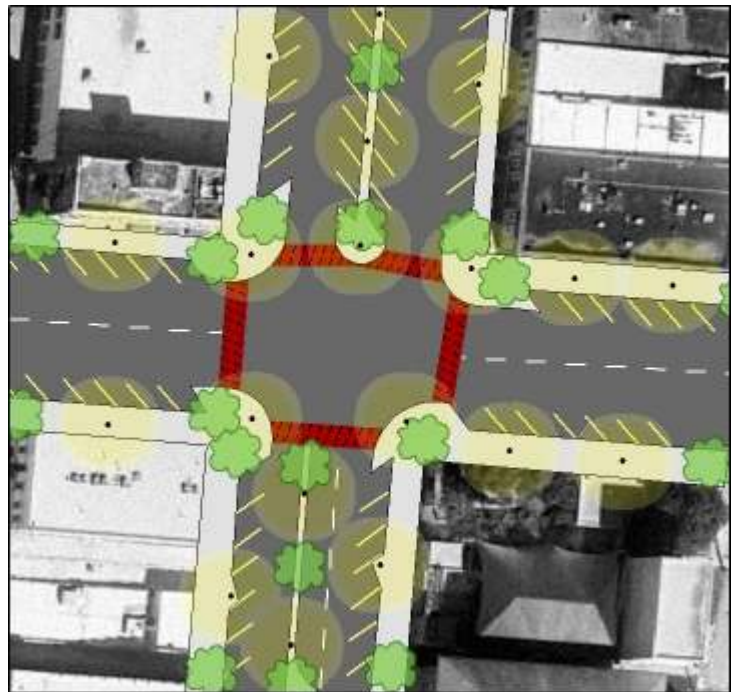
Figure 4.3: Lighting, seating, and tall canopy trees can be placed in bulb outs and sidewalk extensions but should be installed in such a way which maintains visibility at intersections

improvement to urban streetscapes. Figure 4.3 demonstrates the use of bulb outs and sidewalk extensions for placement of other streetscaping elements. Historic themed street lights, benches, trash receptacles, and even street trees may be located in the bulb outs to the benefit of both pedestrians and drivers. Trees with a sufficiently high

canopy are necessary for a well shaded sidewalk and adequate visibility triangle below the lowest branches.

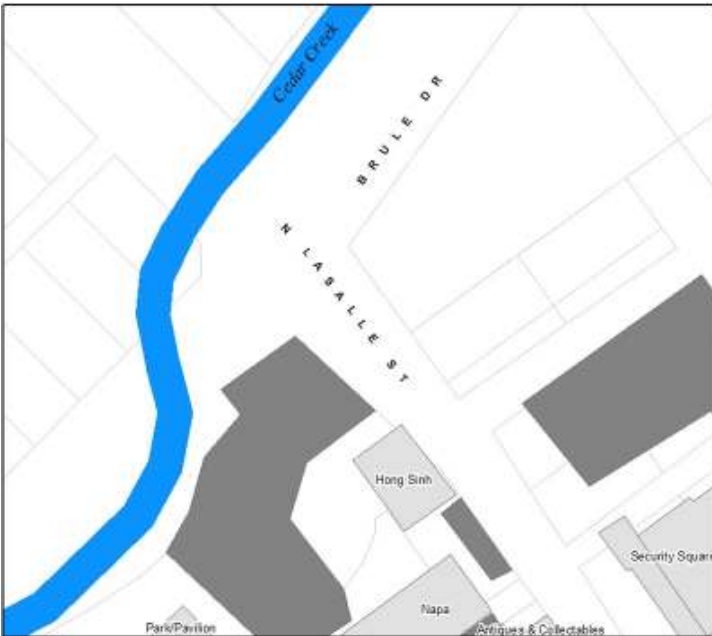
Figure 4.5: Streetscaping improvements and a hike and bike trail extension should be considered for the intersection of LaSalle Street, Brule Drive, and Cedar Creek

Another location within Parking Zone 1 which presents a pedestrian barrier is the intersection of Brule Drive and LaSalle Street (see Figure 4.5). This location is also where Cedar Creek enters Downtown as well as the termination of the existing hike and bike trail. Redevelopment efforts centering around improvements to the Creek

and extension of this trail would depend upon better access for pedestrians crossing LaSalle Street at this point. Possible solutions which should be considered include faux brick pavers, bulb outs, wider sidewalks, and/or a pedestrian underpass. Extension of the trail would provide not only access between parking Zone 1 and 2, but also improve pedestrian access into Downtown from other neighborhoods and population centers within Navasota.

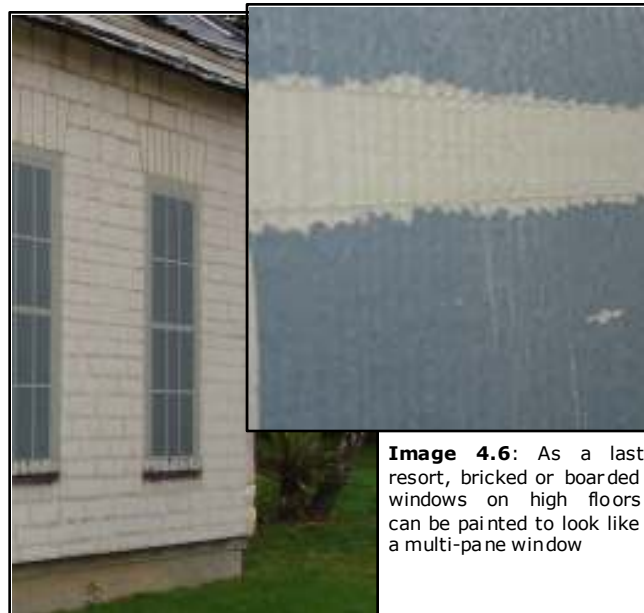
Image 4.6: As a last resort, bricked or boarded windows on high floors can be painted to look like a multi-pane window

One of the best ways to accomplish this is the presence of people, a concept referred to as "eyes on the street" or "defensible spaces." This goal might be accomplished through façade renovations to existing buildings to install office windows and doors. Although only lighted windows will improve conditions at night, even painting a "window" over brick can be a temporary improvement for windows not directly assessable to pedestrians (see Image 4.6). In situations such as second floor windows that have been bricked over this technique might be most useful. Installing opaque or reflective glass windows over the existing bricks is another option.

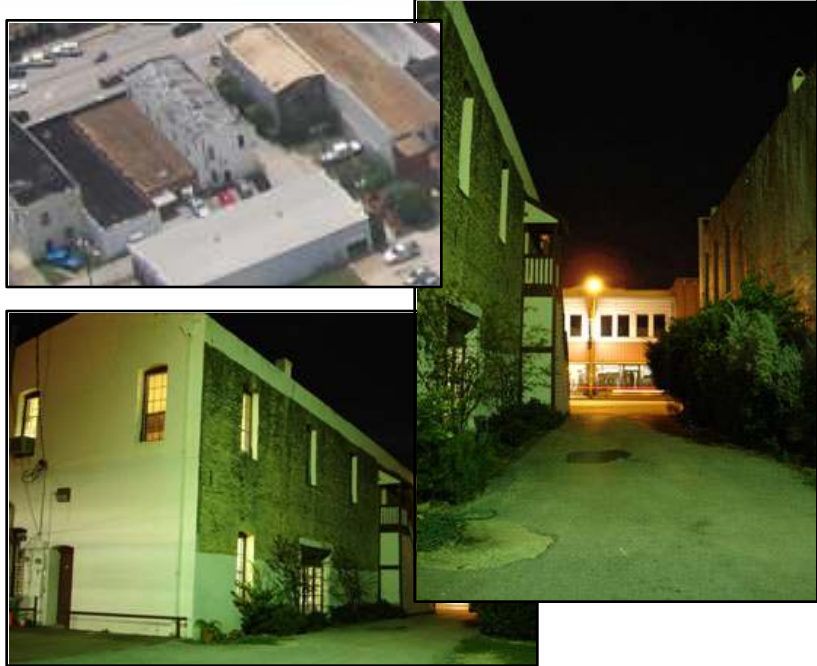
Image 4.8: Alley 1 is designed with appropriate landscaping, lighting, and pedestrian/vehicular mix

Rear entrances to these establishments also permit employees parking in the alley quick access to and from their vehicles, but also contribute to the pedestrian scale. All parts of the alley are well illuminated with lighting located within the alley as well as on adjacent buildings. Landscaping and attractive hardscapeing, such as decorative brick and sidewalks, are also provided in appropriate locations.

Alley 1 (see Figure 4.6) is the best example of a pedestrian friendly alley in Downtown Navasota. (see Image 4.8) In this case three entrances to the alley are provided, with limited vehicular traffic permitted. Large windows in the buildings containing both the law offices and auto-parts store give pedestrians the feeling that they are not alone. Rear entrances to these

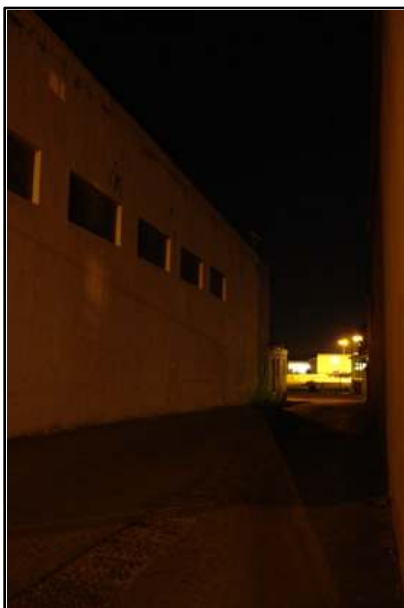
Image 4.9: A lack of direct lighting, landscaping, and lit windows make Alley 2 problematic for pedestrians

surrounding buildings have been bricked closed thus contributing to the sense of isolation felt by pedestrians (see Image 4.9).

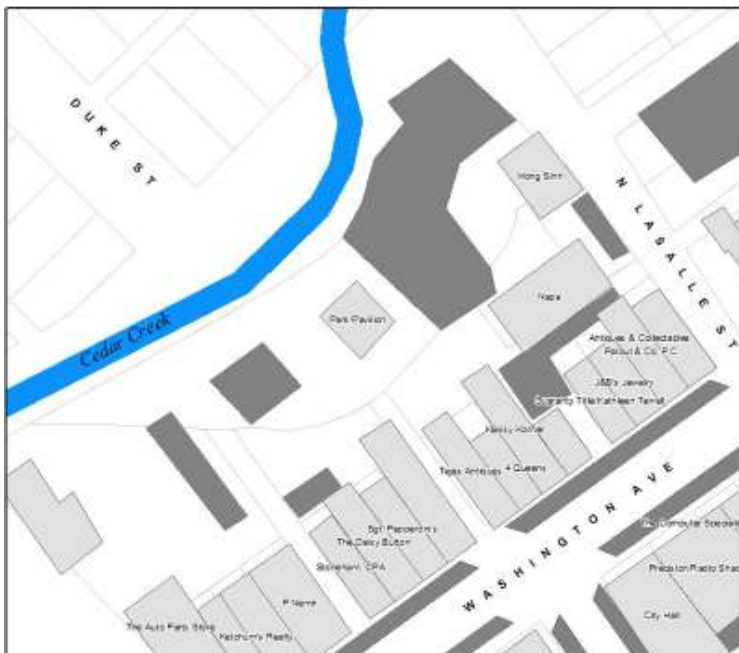
Figure 4.7: Cedar Creek Park and the rear parking lots could benefit from reconfigurations in traffic flow and land use patterns

Attention should also be given to improving aesthetics and safety of the rear-parking lots themselves (see Figure 4.7). Historic style street lighting is used along Cedar Creek and within parts of the parking lots. The style contributes greatly to the pedestrian feel, however, some locations within the parking lot do not receive an adequate level of lighting. It may also be useful for the City to consider replacing high-pressure sodium bulbs which produce a yellow light with a more aesthetically pleasing white light (Metal Halide or Mercury Vapor). Some urban designers maintain that white lighting perpetuates a sense of safety. Maintenance is also important, throughout fieldwork several lights appeared to be burned out (see Image 4.11).

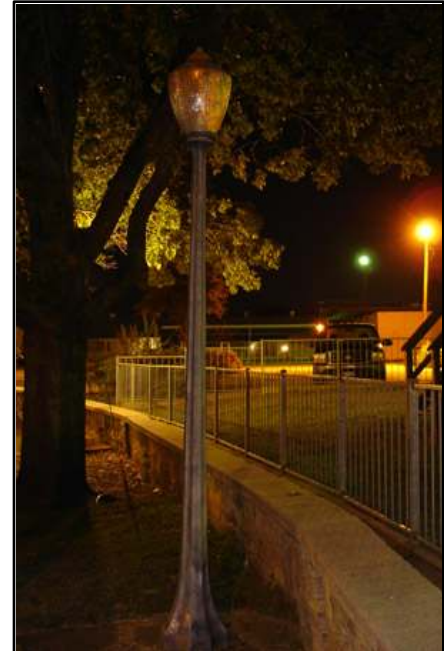
Image 4.11: Mixed bulb types and burned out fixtures are found throughout Downtown

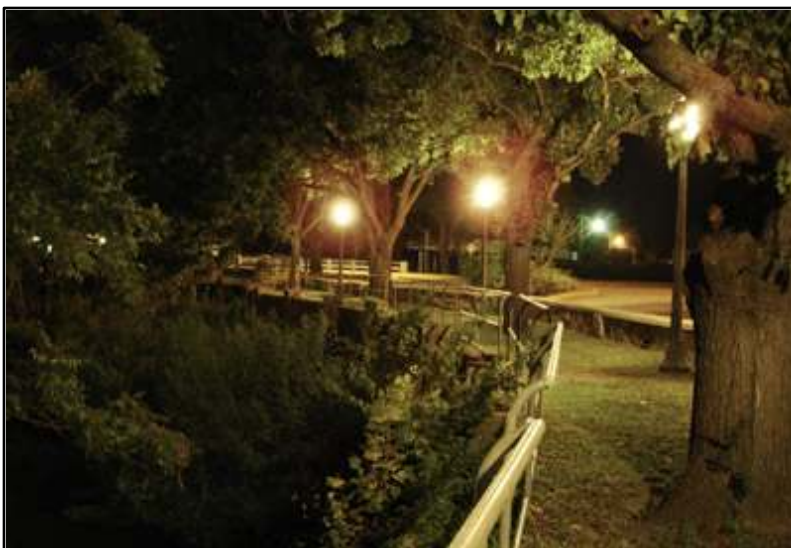
Image 4.12: Mature trees and park amenities make the southern bank of Cedar Creek very appealing and pedestrian friendly even at night

Mature trees along the Creek front give the northern edge of the parking lot an attractive park feel, however, landscaping closer to the buildings is limited or nonexistent (see Image 4.12). Extension of the paved hike and bike trail could further enhance usability of the area.

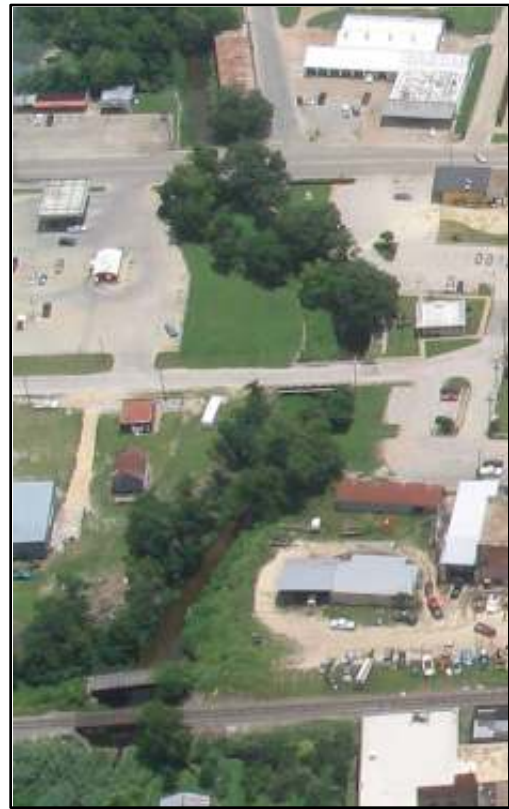
Image 4.13: Several vacant and/or underperforming sites are located along Cedar Creek which could support entertainment-oriented urban development

Another option requiring more redevelopment is the addition of commercial entrances in the rear and sides of some buildings. In some cases, particularly for buildings with backs facing Cedar Creek, renovation may permit entirely separate businesses to exist facing the Creek and park with windows or doors in the alleys as well. The desire to capture Cedar Creek as a "Riverwalk" style attraction was mentioned by multiple respondents during public participation for the Comprehensive Plan. Entertainment, restaurant, and nightclub activities benefit greatly from attractive water features such as creeks or rivers. Underperforming parcels on the northern bank of Cedar Creek not currently considered within Downtown may also be good candidates for urban style development oriented both physically and thematically to the Creek (see Image 4.13). The five parcels in the southern end of the Brookshire Brothers parking

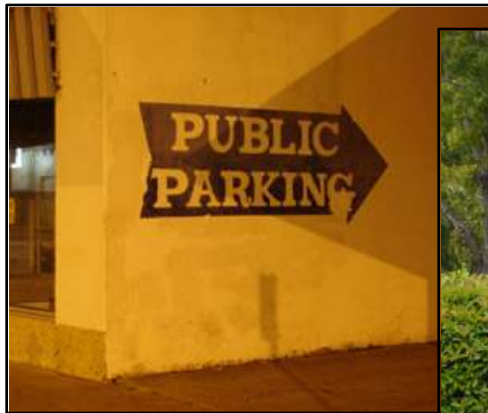
Image 4.14: Lighting, placement, visibility, and design of public parking signs should be addressed to encourage off-street parking lot use

Wayfinding signage is also problematic within Parking Zone 2. Two signs are used to direct motorists from LaSalle Street and Washington Avenue to public parking lots. Neither sign is lit, and both suffer from limited visibility (see Image 4.14). Usage information about Cedar Creek as well as landscaping confuse and obscure visibility of the public parking sign along LaSalle Street. Aging paint and a lack of lighting make the wall sign along Washington Avenue difficult to read at night. Both signs suffer from a lack of consistent design with parking signage in Downtown Navasota as well as with signage found in other cities. Standard signage should drastically improve usability at these locations.

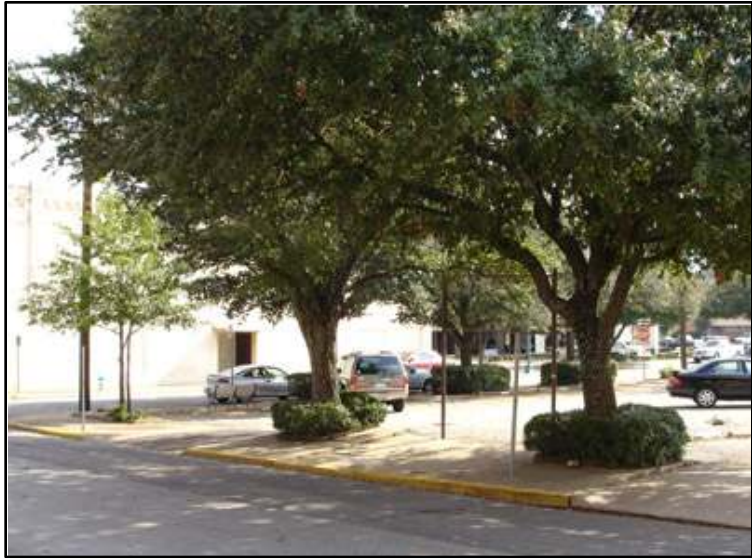
Image 4.15: Well-designed urban parking lots incorporate sidewalks, street trees, and other design elements such as this lot in Palestine, TX

be used to support new tax generating development within this part of Downtown. Design of any parking lot components should be undertaken with attention to preserving the urban feel of Downtown including sidewalks along the street with appropriate landscaping and curb cuts if parking directly abuts the right-of-way (see Image 4.15).

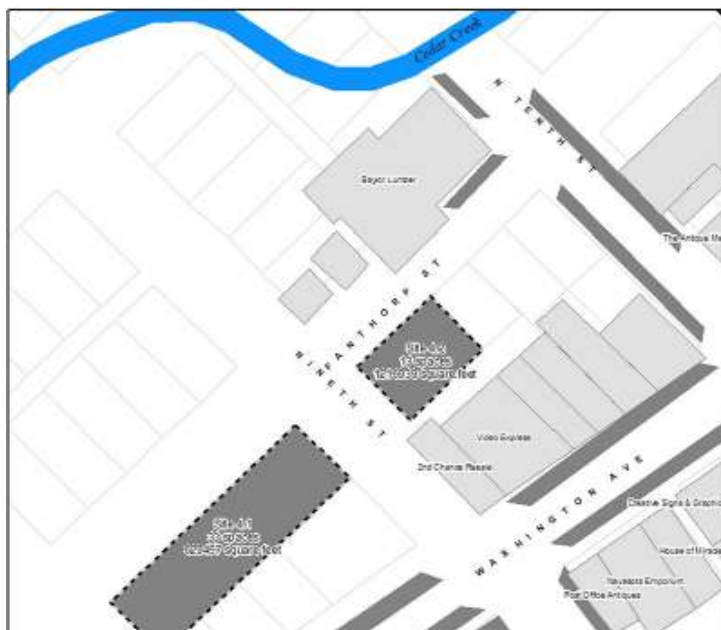
Figure 4.10: Potential parking lot sites in Parking Zone 4

and include off-street parking in the rear. The scenario is illustrated in Figure 4.10, Site 4.1. If the site were developed as shown, approximately 33 parking spaces could be included in the rear parking lot, with about 630,000 square feet of building space per floor along Washington Avenue. Under this scenario the on-street parking on Washington Avenue at this location would also be available.

Off-street parking could also be developed behind the existing buildings along Washington Avenue at the corner of Ninth and Fanthorp Streets, Site 4.2 (see Figure 4.10). Depending on configuration, a parking lot at the site could accommodate 13 parking spaces while serving 1.2 million square feet of existing Downtown buildings. Several back lots in this block are currently used for outside storage and may be potential locations for either parking or new buildings.

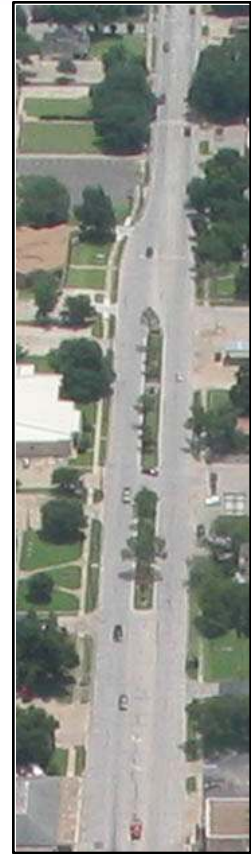
Image 4.16: The landscaped median found on eastern Washington Avenue

Washington Avenue. The installation of the previously described streetscaping improvements including bulb outs may be desirable to improve productivity between structures north and south of Washington Avenue. Public involvement for the Urban Image portion of the 2004 Navasota Comprehensive Plan indicated an interest in the installation of a landscaped median at this location similar to the one found at the eastern entrance of Downtown (see Image 4.16). Such construction would add to other streetscape and gateway improvements.

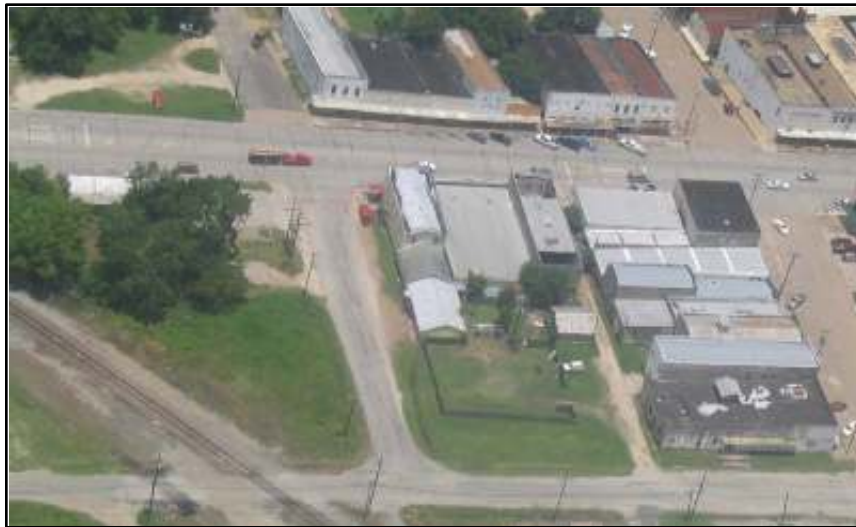
Image 4.17: Undeveloped land in Parking Zone 5

Site 5.2 is located in the rear of buildings fronting along Washington Avenue and Tenth Street. The land is currently fenced and used for a variety of purposes, but lacks major construction (see Image 4.17). Recent redevelopment of the structures fronting on Washington Avenue may necessitate the use of this land for employee and customer parking. The property is currently under private ownership by a landowner who also owns some other redeveloped structures. Given high employee parking currently found along Washington Avenue, relocating employees to such a back lot would drastically reduce the parking shortages currently found here (85% occupied at peak).
