SECTION 4: OVERALL ANALYSIS AND RECOMMENDATIONS

Downtown Navasota Parking Study

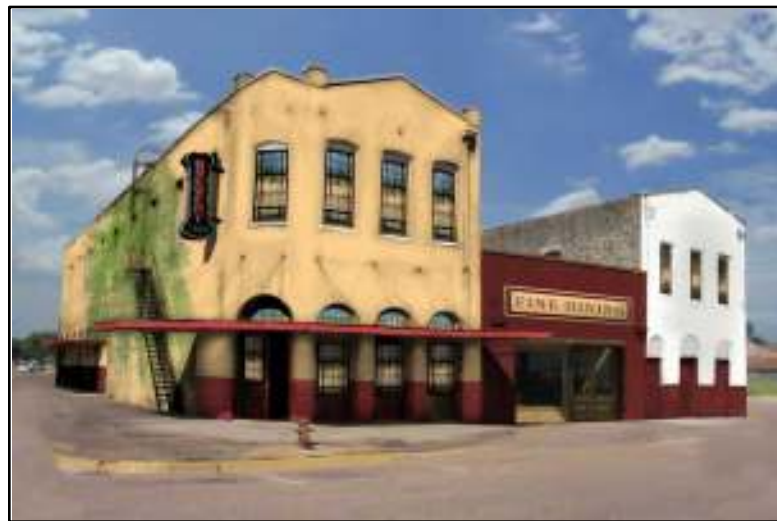
Image 4.2: A major entertainment oriented redevelopment project as proposed in the 2004 Navasota Economic Development Plan within Parking Zone 3 along Railroad Street

Parking Zone 3 contains several structures with vacant floors or are completely vacant including several projects proposed in the Economic Development Plan (see Image 4.2). Development of these and other vacant structures will add about 53 spaces to the zone's existing demand, reducing the surplus from 99

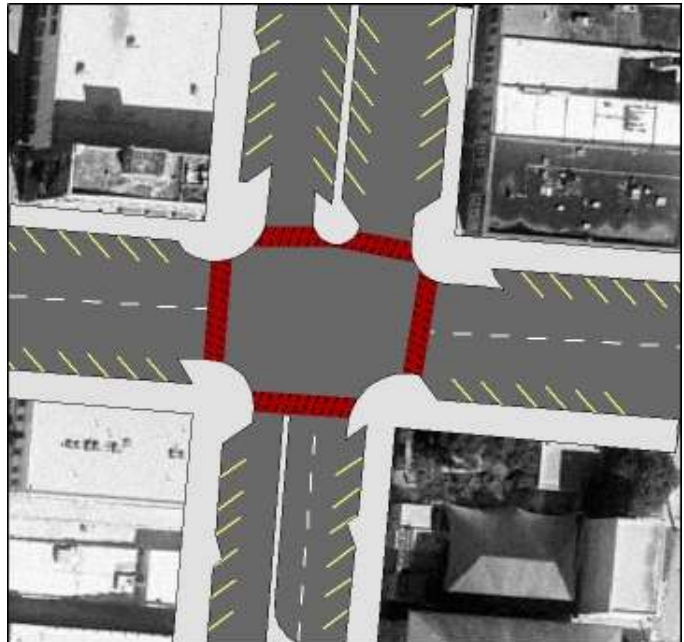
Figure 4.2: Design using bulb outs and faux brick crosswalks which shorten crossing times and aid in pedestrian safety

Figure 4.2 represents the addition of two major urban streetscaping elements, the bulb out and faux brick paved crosswalks. Bulb outs are simply extensions of the sidewalk at

intersections, into what is normally considered the street. Bulb outs are frequently extended to the end of stripes marking on-street parking spaces. They are often designed in a way which permits drainage to flow along the original sidewalk edge. There are several purposes of bulb outs in urban streetscaping. Much like landscape islands in parking lots, bulb outs serve to define the parking row. This design provides an increased level of safety for parked vehicles as well as pedestrians near the corner of intersections.

Bulb outs also shorten the time necessary for pedestrians to cross a road by extending the sidewalk. In this example the average crossing distance for traditional straight sidewalks was 81 feet. At the

generally accepted walking speed of 3.5 feet per second, an average crossing would require 23 seconds. With the bulb out design, the average crossing distance was

reduced to 57.5 feet or approximately 16 seconds. Bulb outs can also provide a location for other streetscaping elements such as street lighting, street trees, and/or benches. It should also be explained that the installation of bulb outs need not result in a loss of on-street parking. In the case of Navasota, on-street parking is not striped close to intersections which is where bulb outs would most likely be employed.

The other streetscaping element included in Figure 4.2 (Page 56) is faux brick paved crosswalks. The use of brick at crosswalks is included for several reasons. In terms of pedestrian safety, any change in color and texture is commonly believed to serve as an effective traffic calming device. Brick pavers are considered much more substantial by most pedestrians and are significantly less likely to succumb to aging and fading as compared to simple painted stripes. Brick pavers also find use as a strictly aesthetic

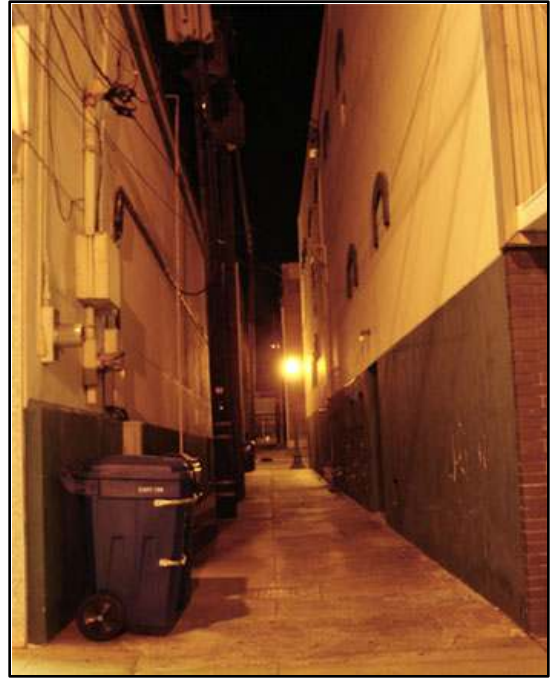
Image 4.7: Even at night clear views and pedestrian scaled lighting make this alley in Palestine, TX less of a perceived hazard

Abundant lighting and clear views are also necessary for pedestrian friendly alleyways (see Image 4.7). Landscaping can also play an important role in improving the alley's appearance, but should be installed in a way which avoids creating potential hiding places and dark spots. A clear view through the alley should be maintained from both Washington Avenue and the rear parking lots. The issue of a proper mix between vehicular and pedestrian

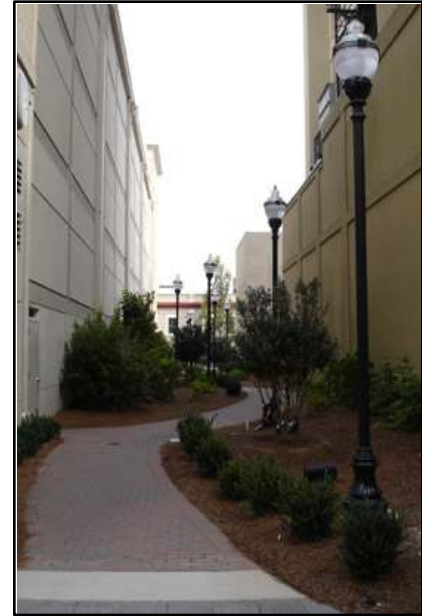
Image 4.10: An example of a well-designed pedestrian mall found in Raleigh, NC

A more radical solution might involve closing one of the alleys to vehicular traffic altogether and creating a fully landscaped and appointed pedestrian mall (see Image 4.10). Such a design could strictly serve as a walkway, or incorporate benches and tables to attract outdoor

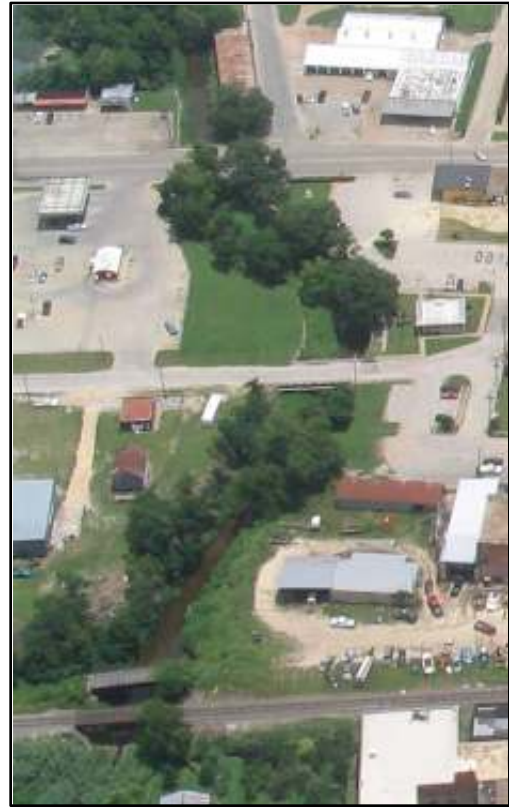
Image 4.13: Several vacant and/or underperforming sites are located along Cedar Creek which could support entertainment-oriented urban development

Another option requiring more redevelopment is the addition of commercial entrances in the rear and sides of some buildings. In some cases, particularly for buildings with backs facing Cedar Creek, renovation may permit entirely separate businesses to exist facing the Creek and park with windows or doors in the alleys as well. The desire to capture Cedar Creek as a "Riverwalk" style attraction was mentioned by multiple respondents during public participation for the Comprehensive Plan. Entertainment, restaurant, and nightclub activities benefit greatly from attractive water features such as creeks or rivers. Underperforming parcels on the northern bank of Cedar Creek not currently considered within Downtown may also be good candidates for urban style development oriented both physically and thematically to the Creek (see Image 4.13). The five parcels in the southern end of the Brookshire Brothers parking
