SECTION 4: OVERALL ANALYSIS AND RECOMMENDATIONS

Specific Recommendations by Parking Zone

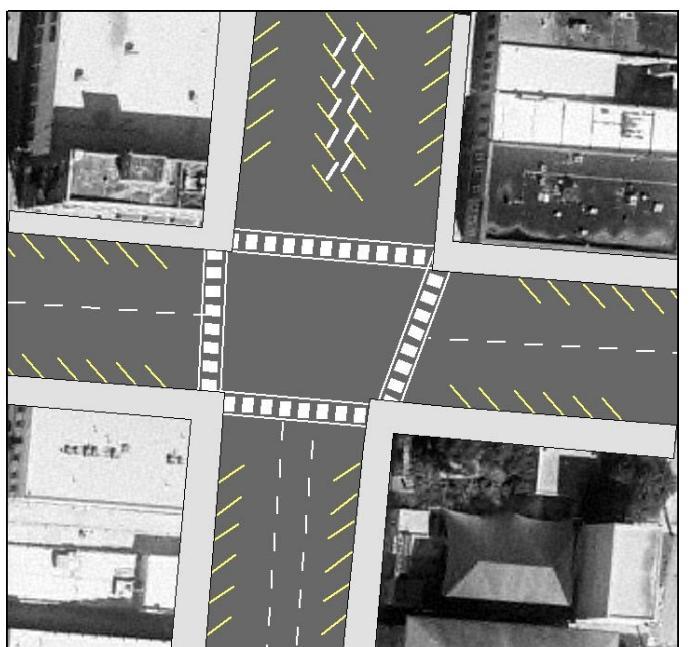
Figure 4.1: Typical sidewalk and crosswalk design

Figure 4.1 is a hypothetical streetscape design which utilizes

many of the concepts that will be discussed. This Figure represents a streetscape not

found unlike those currently in Downtown Navasota. Sidewalks are relatively straight, striped parking is provided with blank areas at intersections, and crosswalks are simply painted white. This design presents several problems for the Because parking pedestrian. is usually not striped all the way to the end of the street, drivers frequently use the un-striped areas as de facto right-turn lanes. Additionally, crosswalks marked with white paint a "solid" marker.

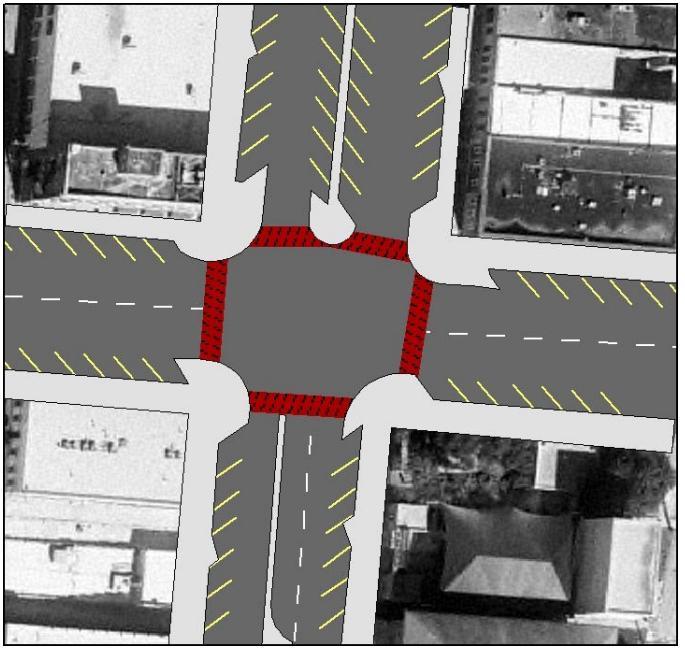
frequently fade and do not represent Figure 4.2: Design using bulb outs and faux brick crosswalks which shorten crossing times and aid in pedestrian safety

Figure 4.2 represents the addition of two major urban streetscaping elements, the bulb out and faux brick paved crosswalks. Bulb outs are simply extensions of the sidewalk at

intersections, into what is normally considered the street. Bulb outs are frequently extended to the end of stripes marking on-street parking spaces. They are often designed in a way which permits drainage to flow along the original sidewalk edge. There are several purposes of bulb outs in urban streetscaping. Much like landscape islands in parking lots, bulb outs serve to define the parking row. This design provides an increased level of safety for parked vehicles as well as pedestrians near the corner of intersections.

Bulb outs also shorten the time necessary for pedestrians to cross a road by the extending sidewalk. In this example the average crossing distance for traditional straight sidewalks was 81 feet. At the

generally accepted walking speed of 3.5 feet per second, an average crossing would require 23 seconds. With the bulb out design, the average crossing distance was

reduced to 57.5 feet or approximately 16 seconds. Bulb outs can also provide а location for other streetscaping elements such as street lighting, and/or street trees, benches. It should also be explained that the installation of bulb outs need not result in a loss of on-street parking. In the

The other streetscaping element included in Figure 4.2 (Page 56) is faux brick paved crosswalks. The use of brick at crosswalks is included for several reasons. In terms of pedestrian safety, any change in color and texture is commonly believed to serve as an effective traffic calming device. Brick pavers are considered much more substantial by most pedestrians and are significantly less likely to succumb to aging and fading as compared to simple painted stripes. Brick pavers also find use as a strictly aesthetic

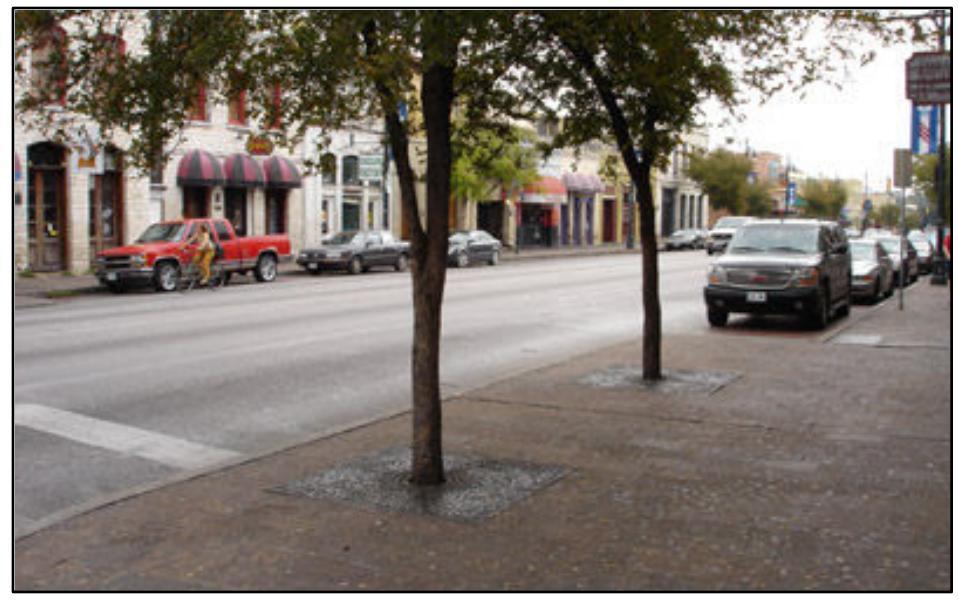
Image 4.4: Bulb out in Downtow n Austin, TX with young street trees and brick paving

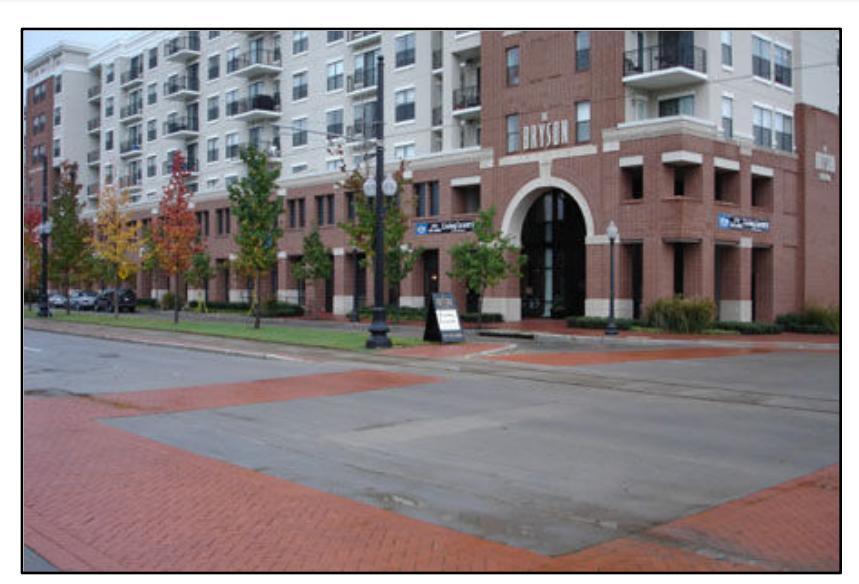
Image 4.5: Brick paved crosswalks in Dallas, TX

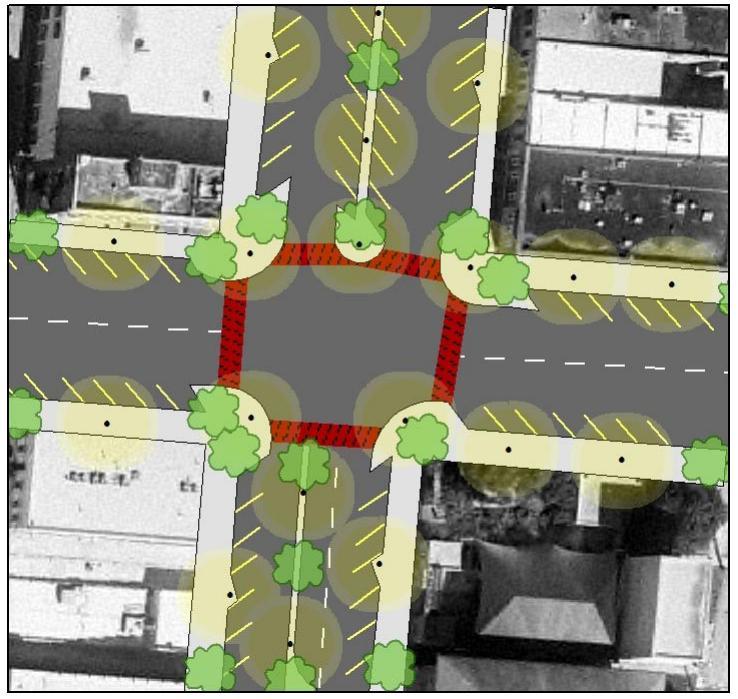
Figure 4.3: Lighting, seating, and tall canopy trees can be placed in bulb outs and sidewalk extensions but should be installed in such a way which maintains visibility at intersections

improvement to urban streetscapes. Figure 4.3 demonstrates the use of bulb outs and sidewalk extensions for placement of other streetscapeing elements. Historic themed street lights, benches, trash receptacles, and even street trees may be located in the bulb outs to the benefit of both pedestrians and drivers. Trees with a sufficiently high

canopy are necessary for a well shaded sidewalk and adequate visibility triangle below the lowest branches.

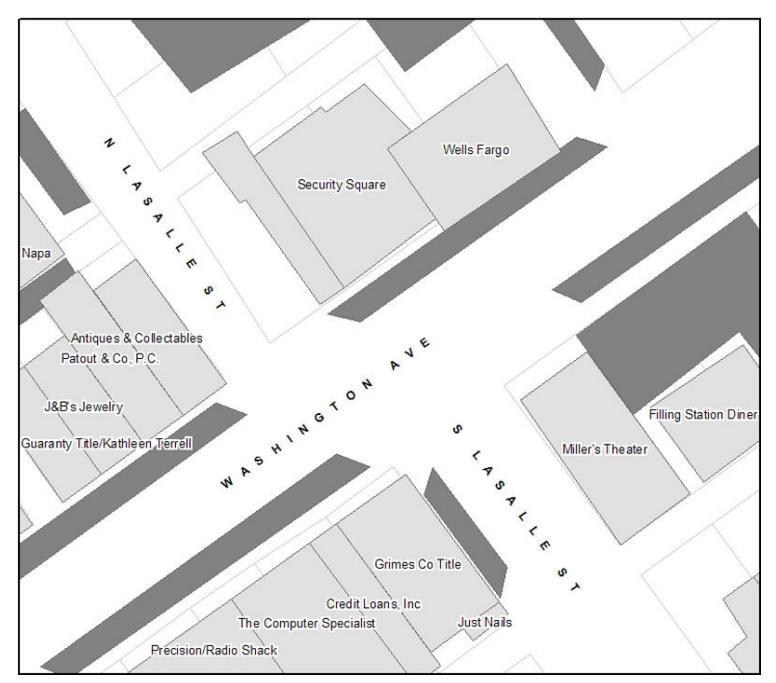
Figure 4.4: Streetscaping improvements should be considered at the intersection of Washington Avenue and LaSalle Street

The intersection of Washington LaSalle Avenue and Street would be the most logical location for these improvements (see Figure 4.4). The use of bulb outs and faux brick pavers at crosswalks may significantly reduce the time and danger involved in crossing the intersection that pedestrians currently face. The intersection already suffers from an unusual alignment for traffic traveling on LaSalle Street which may preclude the

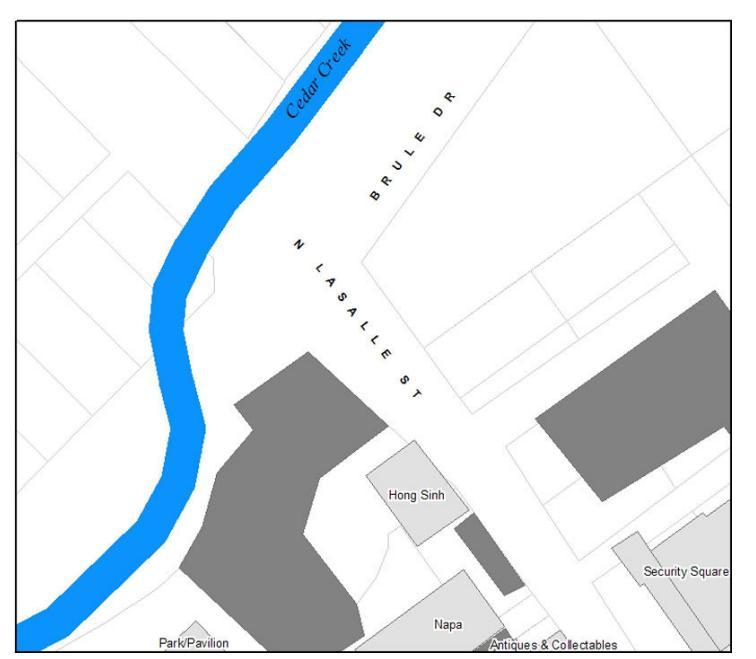
Another location within Parking Zone 1 which presents a pedestrian barrier is the intersection of Brule Drive and LaSalle Street (see Figure 4.5). This location is also where Cedar Creek enters Downtown as well as the termination of the existing hike and bike trail. Redevelopment efforts centering around improvements to the Creek

Figure 4.5: Streetscaping improvements and a hike and bike trail extension should be considered for the intersection of LaSalle Street, Brule Drive. and Cedar Creek

and extension of this trail would depend upon better access for pedestrians crossing LaSalle Street at this point. Possible solutions which should be considered include faux brick bulb outs, pavers, wider sidewalks, and/or a pedestrian underpass. Extension of the trail would provide not only access between parking Zone 1 and 2, but also improve pedestrian access into Downtown from other neighborhoods and population centers within Navasota.

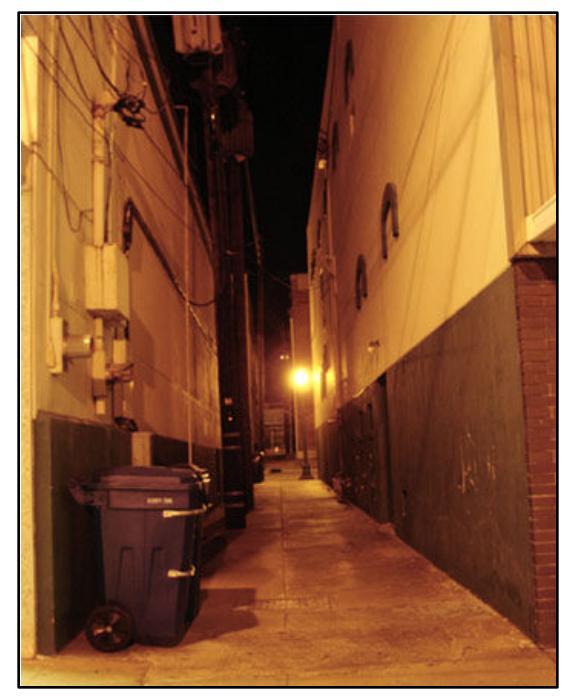
Image 4.7: Even at night clear views and pedestrian scaled lighting make this alley in Palestine, TX less of a perceived hazard

Abundant lighting and clear views are also necessary for pedestrian friendly alleyways (see Image 4.7). Landscaping can also play an important role in improving the alley's appearance, but should be installed in a way which avoids creating potential hiding places and dark spots. A clear view through the alley should be maintained from both Washington Avenue and the rear parking lots. The issue of a proper mix between vehicular and pedestrian

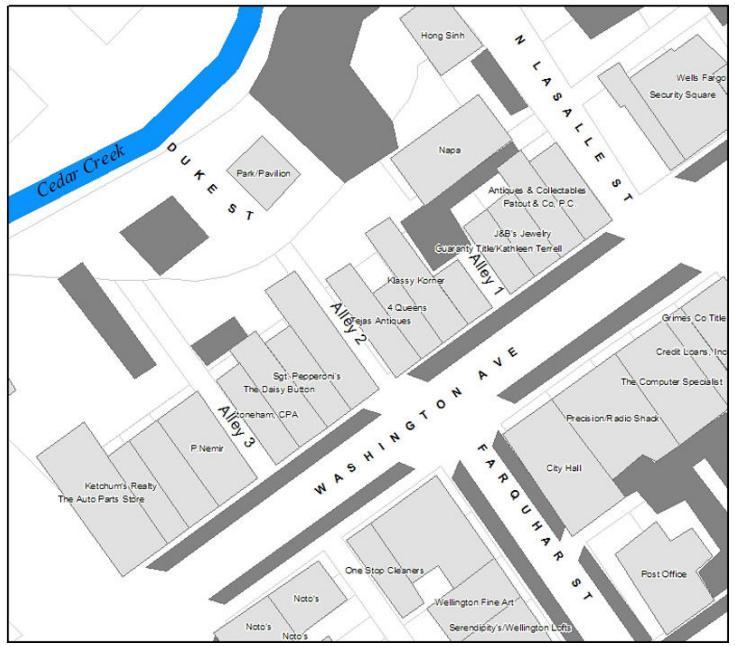
Figure 4.6: Alley locations in Parking Zone 2

Alley 1 (see Figure 4.6) is the best example of a pedestrian friendly alley in Downtown Navasota. (see Image 4.8) In this case three entrances to the alley are provided, with limited vehicular traffic permitted. Large windows in the buildings containing both the law offices and auto-parts store give pedestrians the feeling that they are not alone. Rear entrances to these

Alley 2, which makes up the final block of Duke Street, intersects Washington Avenue just to the west of Tejas Antiques and across from Farquhar Street (see Figure 4.6). This access point is significantly less pedestrian friendly. Two-way vehicular traffic within the long and narrow space creates an intimidating situation for pedestrians, with no sidewalks or striping provided to define a pedestrian zone. Additionally, lighting and landscaping are completely absent. Street lighting from Washington Avenue illuminates the southern entrance to the alley, however, the 45 yard span remains very dark during the evenings and early mornings. Further compounding the situation, many windows on the

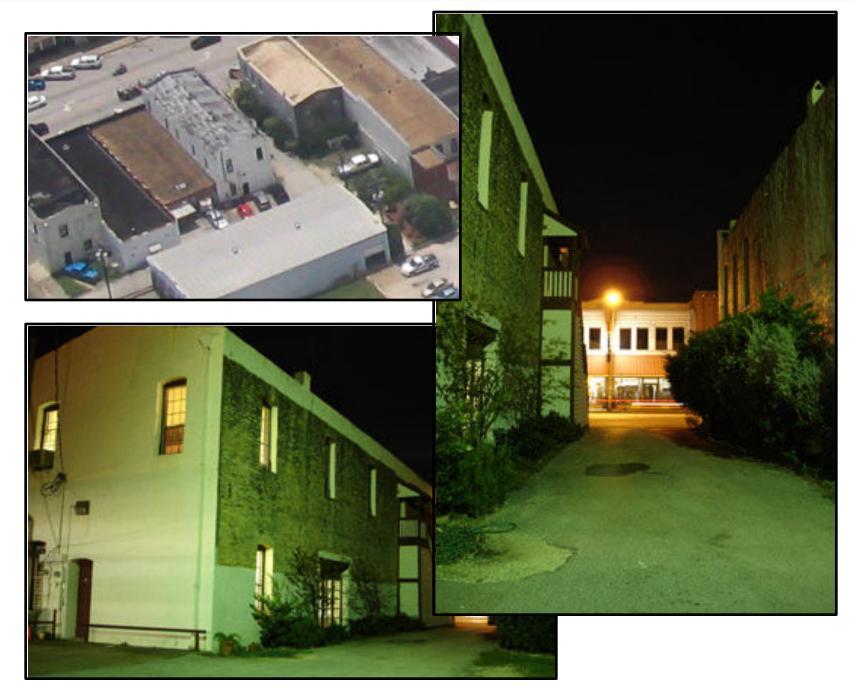
Image 4.8: Alley 1 is designed with a ppropriate landscaping, lighting, and pedestrian/vehicular mix

establishments also permit employees parking in the alley quick access to and from their vehicles, but also contribute to the pedestrian scale. All parts of the alley are well illuminated with lighting located within the alley as well as on adjacent buildings. Landscaping and attractive hardscapeing, such as decorative brick and sidewalks, are also provided in appropriate locations.

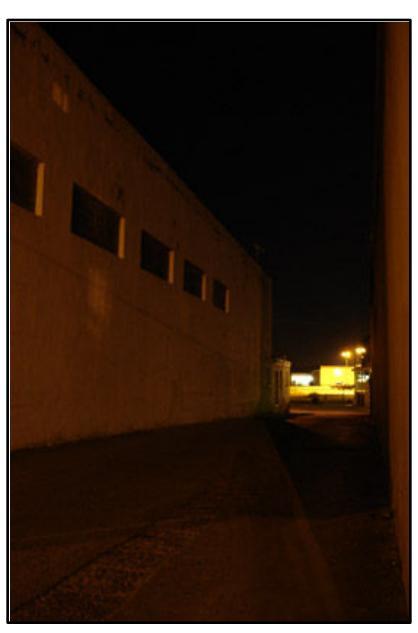
Image 4.9: A lack of direct lighting, landscaping, and lit windows make Alley 2 problematic for pedestrians

surrounding buildings have been bricked closed thus contributing to the sense of isolation felt by pedestrians (see Image 4.9).

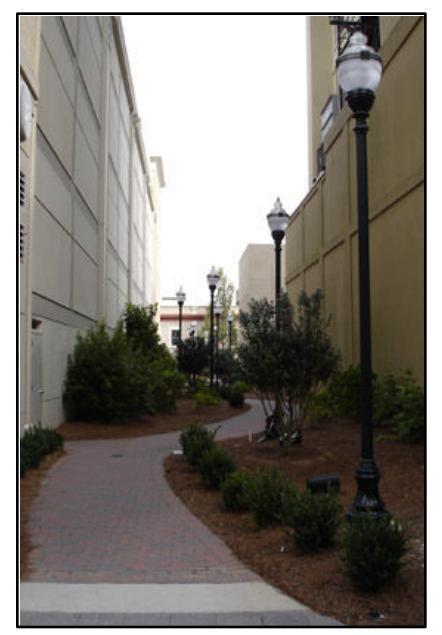
Image 4.10: An example of a well-designed pedestrian mall found in Raleigh, NC

A more radical solution might involve closing one of the alleys to vehicular traffic altogether and creating a fully landscaped and appointed pedestrian mall (see Image 4.10). Such a design could strictly serve as a walkway, or incorporate benches and tables to attract outdoor

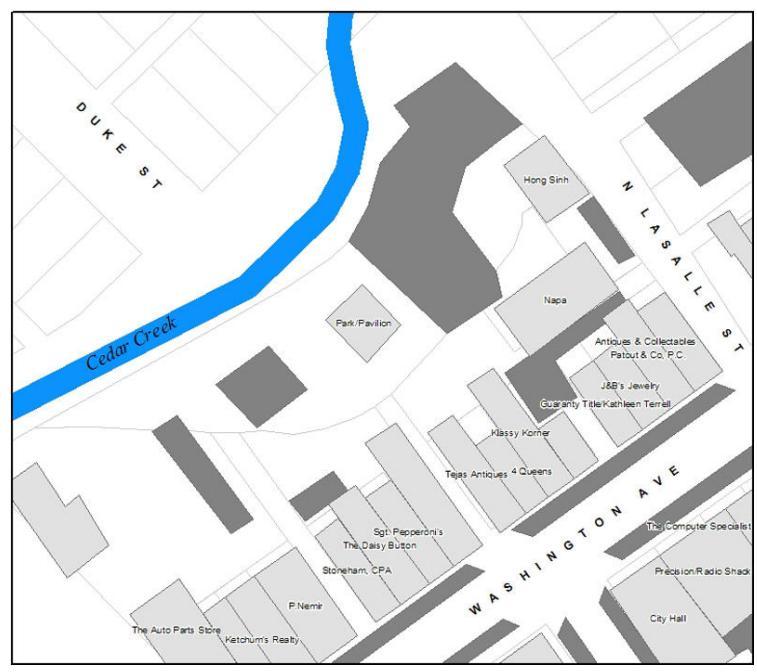
Figure 4.7: Cedar Creek Park and the rear parking lots could benefit from reconfigurations in traffic flow and land use patterns

Attention should also be given to improving aesthetics and safety of the rear-parking lots themselves (see Figure 4.7). Historic style street lighting is used along Cedar Creek and within parts of the parking lots. The style contributes greatly to the pedestrian feel, however, some locations within the parking lot do not receive an adequate level of It may also be useful for the City to lighting. consider replacing high-pressure sodium bulbs which produce a yellow light with a more aesthetically pleasing white light (Metal Halide or Mercury Vapor). Some urban designers maintain that white lighting perpetuates a sense of safety. Maintenance is also important, throughout fieldwork several lights appeared to be burned out (see Image 4.11).

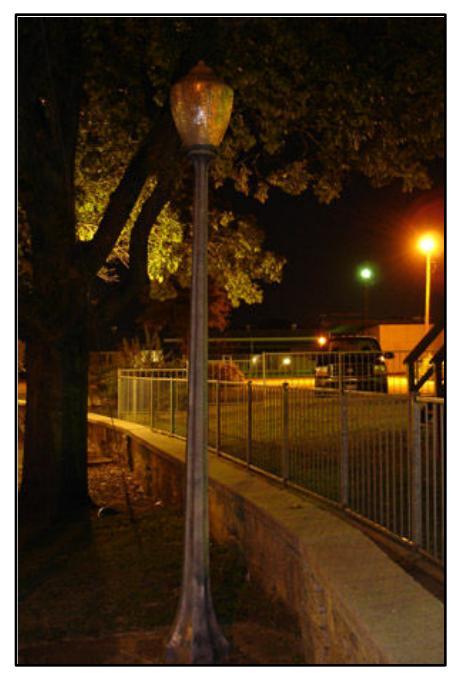
Image 4.11: Mixed bulb types and burned out fixt ures are found throughout Downtow n

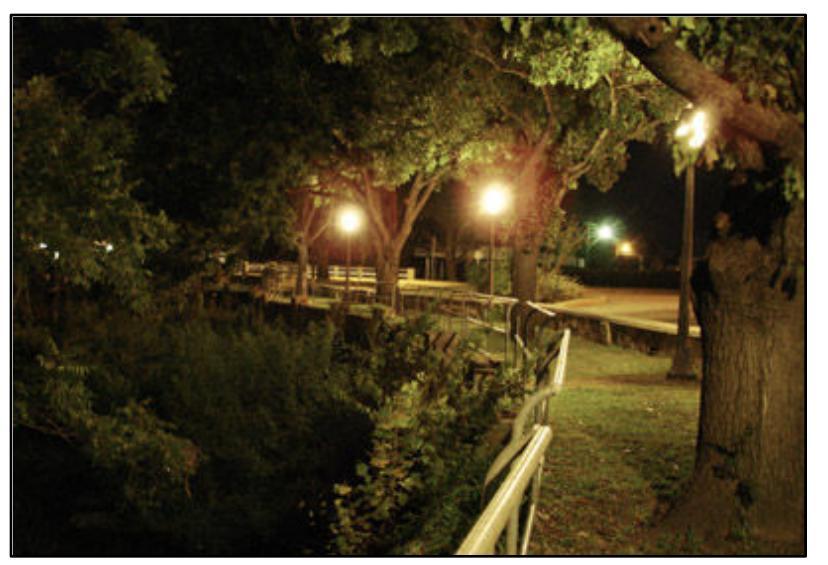
Image 4.12: Mature trees and park amenities make the southern bank of Cedar Creek very appealing and pedestrian friendly even at night

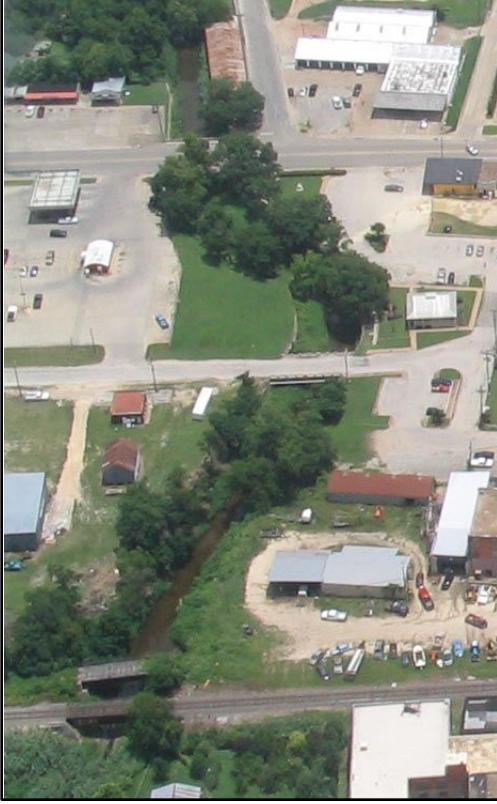
Another option requiring more redevelopment is the addition of commercial entrances in the rear and sides of some buildings. In some cases, particularly for buildings with backs facing Cedar Creek, renovation may permit entirely separate businesses to exist facing the Creek and park with windows or doors in the alleys as well. The desire to capture Cedar Creek as a "Riverwalk" style attraction was mentioned by multiple respondents during public participation for the Comprehensive Plan. Entertainment, restaurant, and nightclub activities benefit greatly from attractive water features such as creeks or rivers. Underperforming parcels on the northern bank of Cedar Creek not currently considered within Downtown may also be good candidates for urban style development oriented both physically and thematically to the Creek (see

Image 4.13: Several vacant and/or underperforming sites are located along Cedar Creek which could support entertainment-oriented urban development

Image 4.13). The five parcels in the southern end of the Brookshire Brothers parking

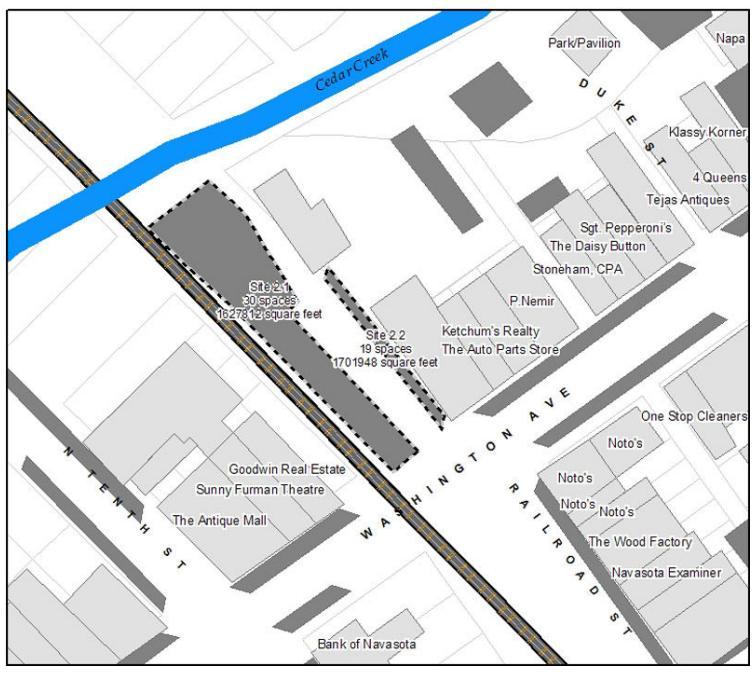
Figure 4.8: A potential parking lot site in Parking Zone 2

improvements and internal landscaping could provide space for both public parking and some continued use by the automotive service facility. On-street parking similar the parking to along Railroad Street could also installed be to give continuity in urban design.

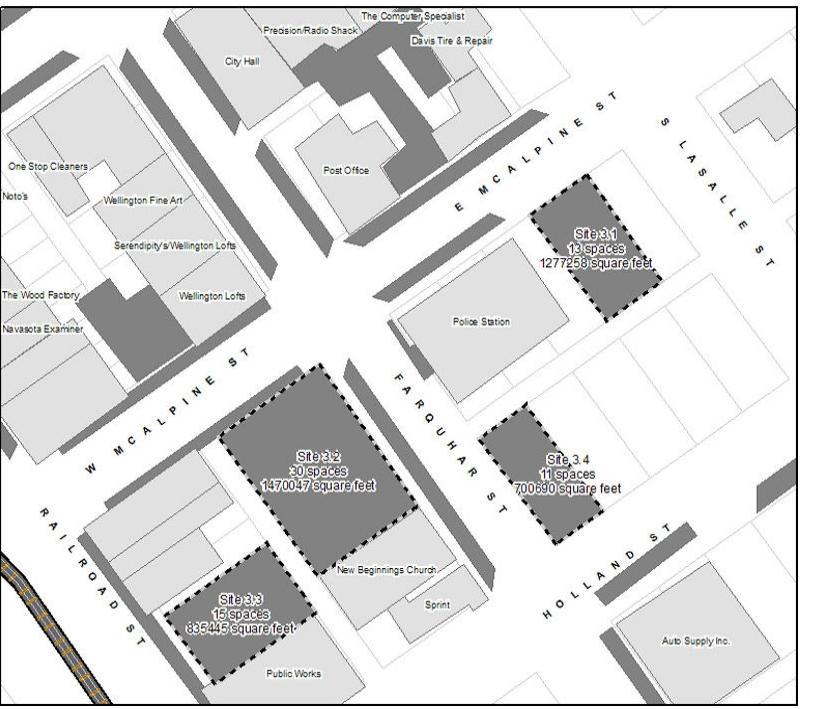
Figure 4.9: Potential parking lot sites in Parking Zone 3

identified by Butler Planning Services not by any representative of the City of Navasota. The four identified tracks are all unimproved land within reasonable proximities to significant downtown development. Table 4.4 summarizes the strengths and weaknesses of each option. The number of potential spaces within each site is derived using the average density of parking spaces currently built within Downtown. Therefore, this number may be higher or lower than the actual number of spaces possible given specific site conditions and space utilized for parking lot amenities such as landscaping. Building square footage for each parking lot is an estimate of the total square footage of Downtown buildings found within a 300 foot buffer of the parking lot site.

Given the advantages and limitations presented by each option, it is recommended that the City continue work through the established task force to build a parking lot at Site 3.1 (see Figure 4.9). The potential amenities suggested by this task force including a clock tower and public plaza would also fit well with the goals of the 2004 Navasota Comprehensive Plan and this study. Namely, the establishment of a southern gateway and the provision of parking designed in a matter compatible with the desired urban form. Such design should take precedence over maximizing the total parking on the site.

It is also recommended that the City explore possible development options for a future parking lot located on Site 3.2 with the current owner. Development incentives, public/private partnerships, or outright City purchase may be beneficial to all parties.

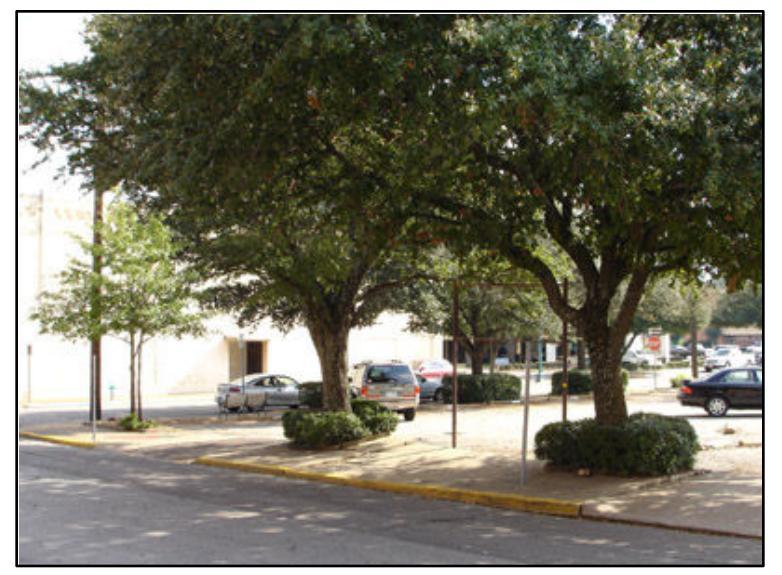
$\label{eq:Image 4.15} \textbf{Image 4.15}: \ Well-designed urban parking lots incorporate sidewalks, \ street trees, \ and \ other \ design \ elements \ such \ as \ this \ lot \ in \ Palestine, \ TX$

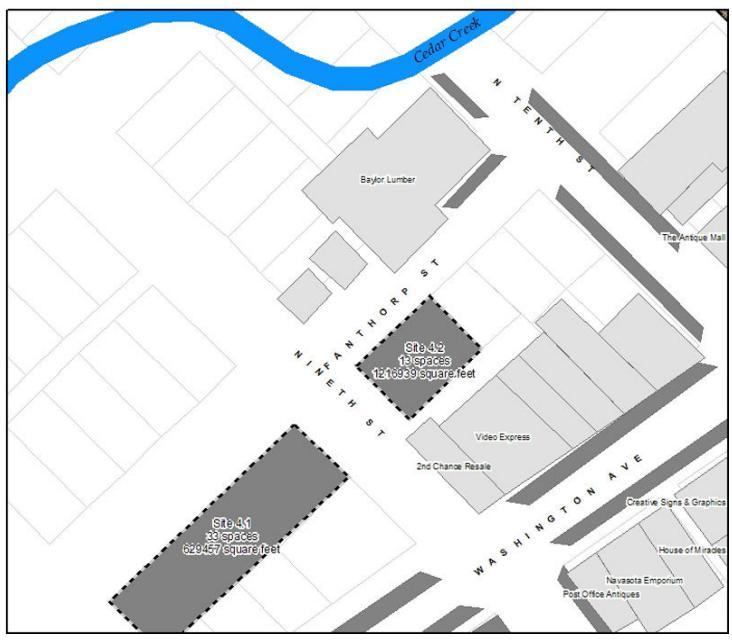
Figure 4.10: Potential parking lot sites in Parking Zone 4

Iocated at the Table 4.5: Service statistics for potential parking lot sites in Parking Zone western extent of the zone with frontage along Washington Avenue. Trailers and vehicles with "for sale" signs are occasionally parked on these lots. If redevelopment of Downtown progresses to a point where land values justify development on these lots, one option would be for the owner to build structures along Washington Avenue

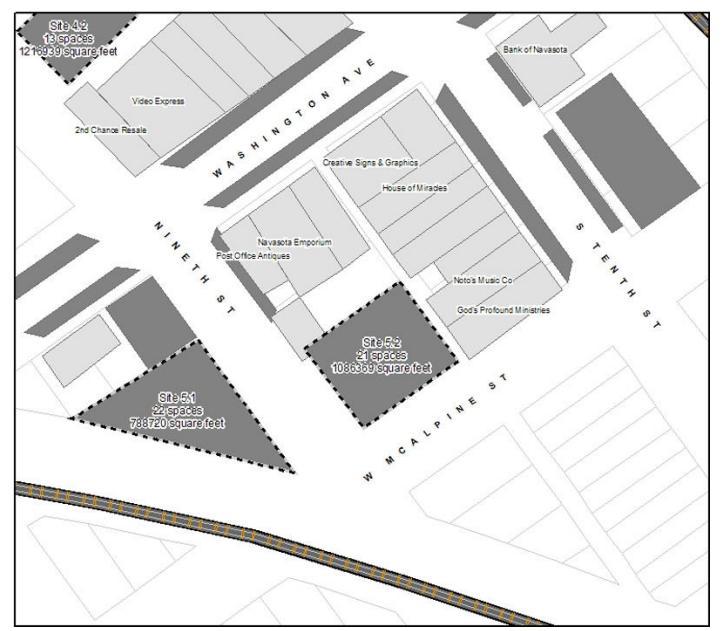
Figure 4.11: Potential parking lot sites in Parking Zone 5

As for off-street parking within the zone, several possibilities exist. Site 5.1 is currently unimproved land fronting Ninth Street in the east, and the railroad right-of-way in the west (see Figure 4.11, Image 4.16). Α well used but physically distressed building is

Site 5.2 is located in the rear of buildings fronting along Washington Avenue and Tenth Street. The land is currently fenced and used for a variety of purposes, but lacks major construction (see Image 4.17). Recent redevelopment of the structures fronting on Washington Avenue may necessitate the use of this land for employee and customer parking. The property is currently under private ownership by a landowner who also owns some other redeveloped structures. Given high employee parking currently found along Washington Avenue, relocating employees to such a back lot would drastically reduce the parking shortages currently found here (85% occupied at peak).
